Aerial Parcel A

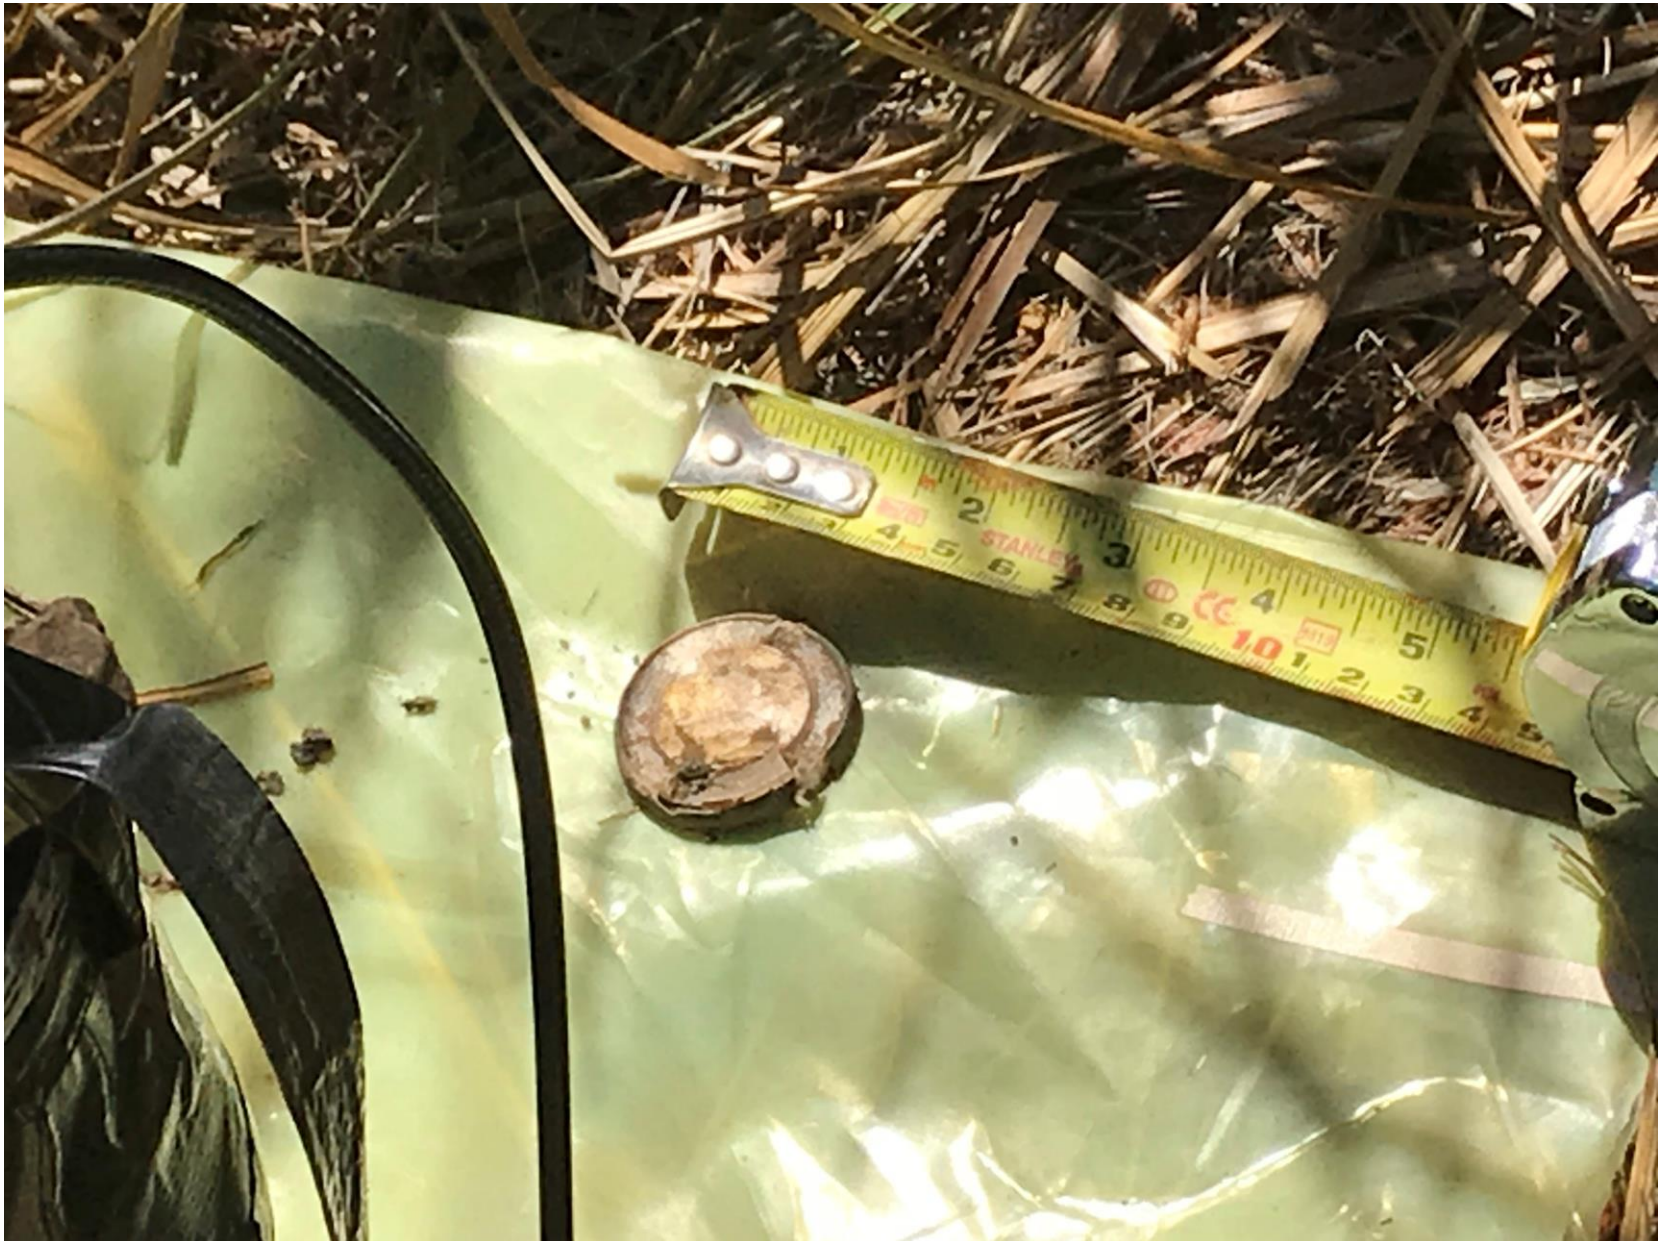
Dose in micro Roentgens/hour (uR/hr) using uR meter	Counts per minute (cpm) using 2X2 Sodium Iodide detector	Explanation
5 uR/hr	8,000 cpm	Reference Background – all accessible areas of the sloped area 8,000 cpm. After removing the deck marker, the hole and excavated soil showed roughly 8,000 cpm
80 uR/hr	77,000 cpm	Measured at surface before excavation. Deck marker was found 10.5 inches deep. This level would be consistent with naturally occurring Sierra granite or radiological devices previously found onsite
2,000 uR/hr		NRC and State CDPH threshold for restricting public access and posting warning signs. (NRC applies this to visitors to currently operating facilities)
3,100-3,400 uR/hr measured at direct contact with deck marker	208,000 cpm measured 1 ft from deck marker	After source was excavated. Previous similar sources found on site showed 90,000 cpm at 4 inch distance.
